The BARN

at Ivy Creek

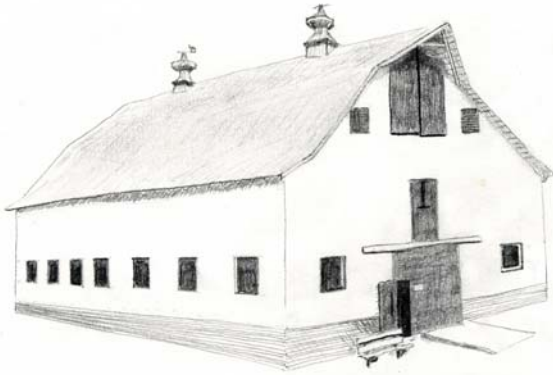
The barn at the Ivy Creek Natural Area was built in the early 1930s by the Conley Greer family as a modern, up-to-date facility. It housed horses, cows, pigs, and the winter food supply necessary for successful livestock farming. Conley Greer was Albemarle County's first African-American agricultural extension agent and he used his farm as a model for other farmers in the area. The barn's construction was unique in part because trees growing on the farm, sawn into lumber by a portable sawmill, provided the building material. The barn has been restored to resemble what we believe is its original design, while maintaining openness and room for an office and a classroom.

As you approach the barn, you will see large doors that open to reveal a wide center aisle, leading to another set of doors at the opposite end. This new barn design allowed horses to pull wagons the entire length of the barn, thereby eliminating the need to use wheelbarrows for the heavy work of cleaning and maintaining the barn. (thumbnail picture)

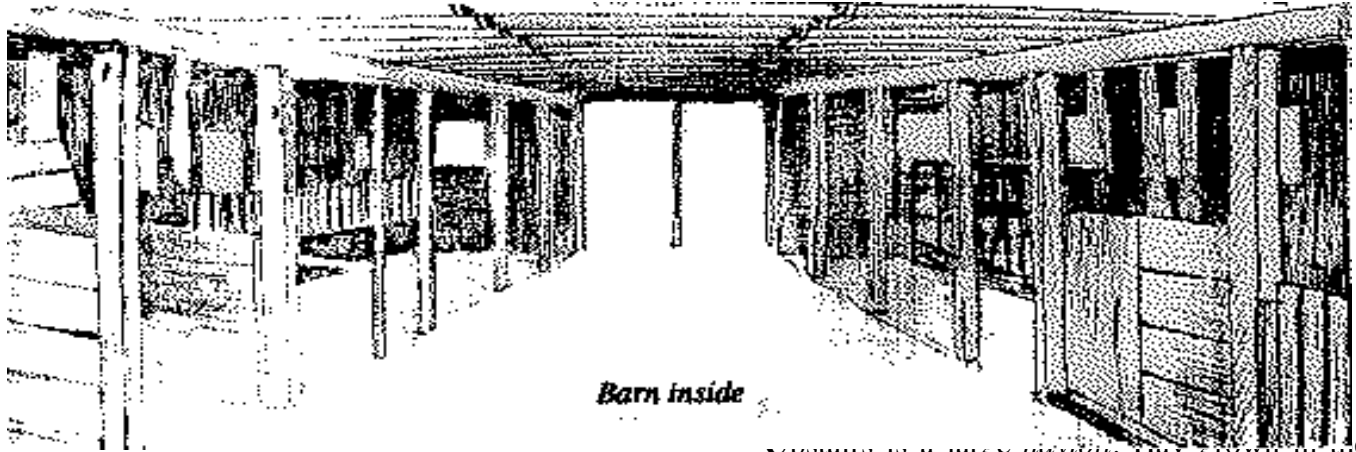
Barn inside

At the far end of the barn are the *stanchions*, *stalls*, *gutters*, and *feed troughs*, where the milk cows were kept. The cows were confined to the stalls with their heads through the stanchions. They ate from the feed trough, rested on the platform, and used the gutter as their bathroom. They stayed in these stalls the entire day during the winter except to go outside once or twice a day for water and exercise. Morning and evening, they were fed grain from the granary. hay from the hayloft was fed three or four times a day.

The cows were milked by hand morning and evening. A mechanical separator behind the cows separated the cream from the milk. The cream was placed into containers and promptly cooled by water from the spring and later sold to a creamery. The skim milk, while still warm, was poured into the pig trough for the sows and baby pigs.

Across the aisle from the milk cows, where the seats for the classroom are now located, was a series of pens used to house growing calves, heifers, steers, and bulls. Cows preparing to give birth were also kept there. The animals in the pens were fed hay and grain in the aisle near the windows. The upright boards near the feed aisle functioned to provide feeding stations for the calves as they ate and prevented dominant animals from crowding hungry neighbors away.

Between the stanchions and the utility pen is evidence of a solid partition that went across the barn. Health regulations of the time required that milking cows be separated from other animals in the same barn. Calves, heifers, steers, and bulls could be kept with the cows or with horses and pigs, but the cows producing milk could be housed only by themselves or with other cattle.
